Manhole Inspection Summary

Manhole # S39YY_002MH

Insp Date: **12/14/06 9:45 AM**

Location Address: **3224 AVON AVE**

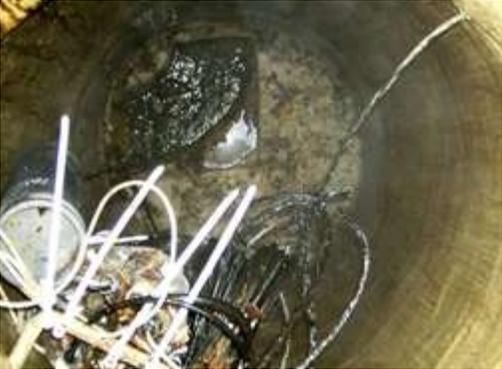
Top View

Bench debris.

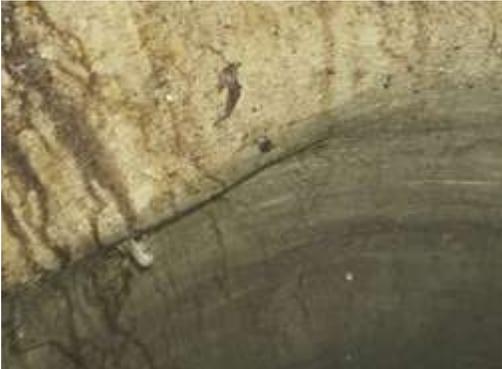
Defect

Infiltration: None **Joint** Cracks Mortar Roots **Wall**

Adjustment infiltration. Corbel bulge.

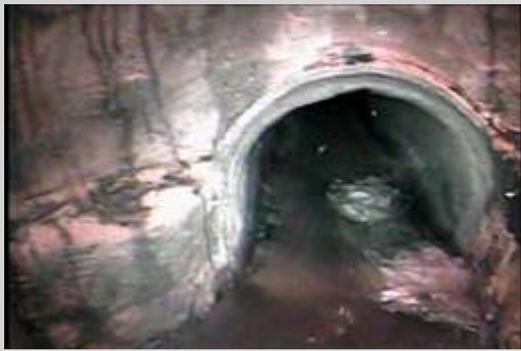
15 in. Circular Gravity Sewer Pipe Out @ 12 O'Clock

Invert Depth: **11.70** (ft.) Flow Characteristics: **Slow**

Silt Depth: **0** (in.) Deposits Extent: **Light**

Infiltration: **None** Pipe Seal Cond: **Unknown**

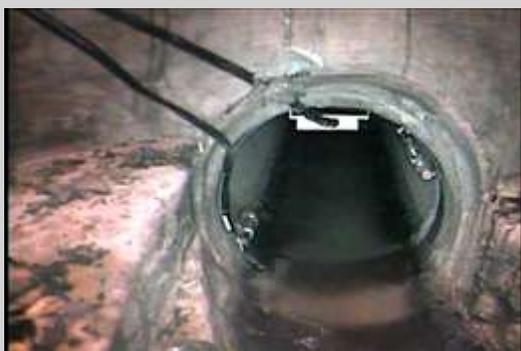
15 in. Circular Gravity Sewer Pipe In @ 9 O'Clock

Invert Depth: **11.66** (ft.) Flow Characteristics: **Slow**

Infiltration: **None** Pipe Seal Cond: **Unknown**
